# **Local and Regional Environmental Impacts from the U.S. Metals Refining Company Facility Operations in Carteret, New Jersey**

Prepared for

**Reichhold, Inc.**

August 2008

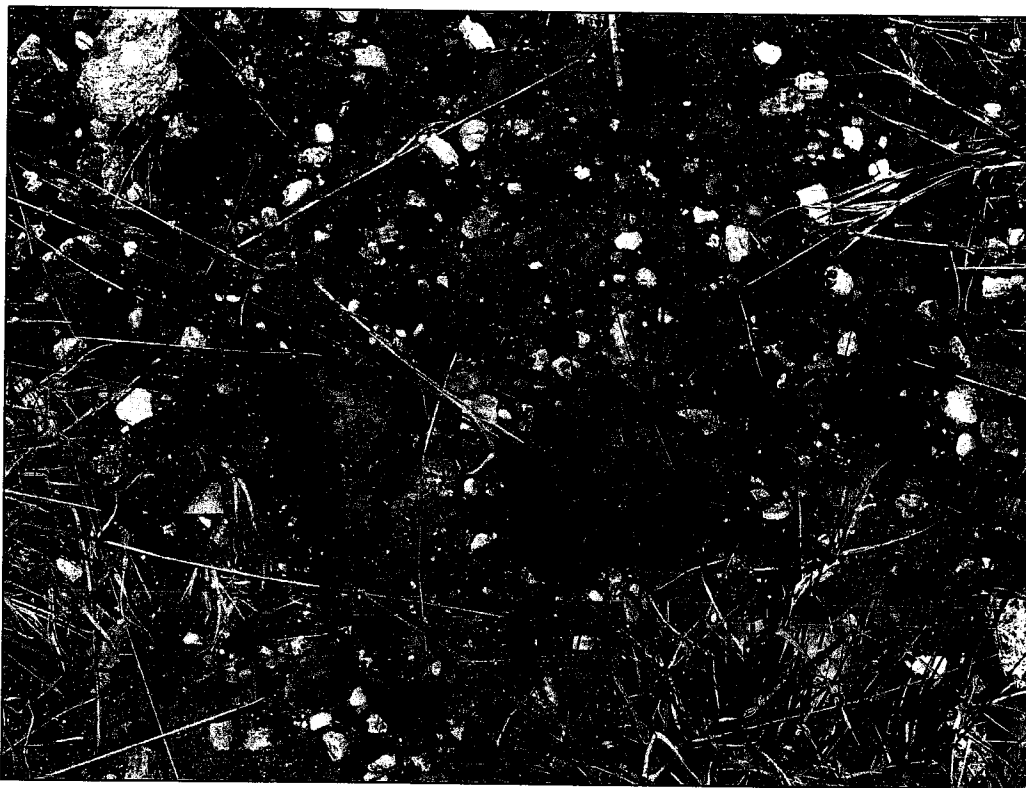
**LOCATION 1-PHOTO 3:** USMR PROPERTY SLAG COVERED SOILS NEAR MW, TUFTS POINT MARSH, AND FORMER USMR SLAG STORAGE AREA (04/23/2008).

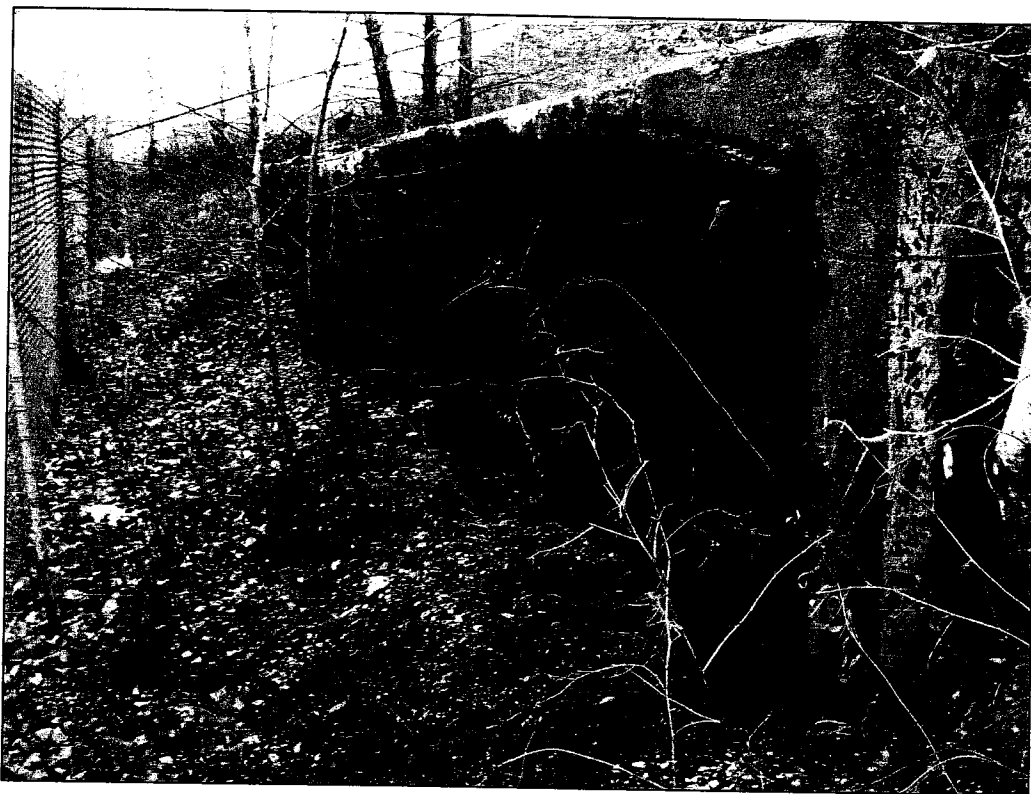
**LOCATION 5-PHOTO 1:** SLAG MATERIAL ON SURFACE AT EDGE OF FORMER REICHOLD AND USMR PROPERTY AND FENCE LINE NEAR CONCRETE BLOCKS (WINTER 2008).

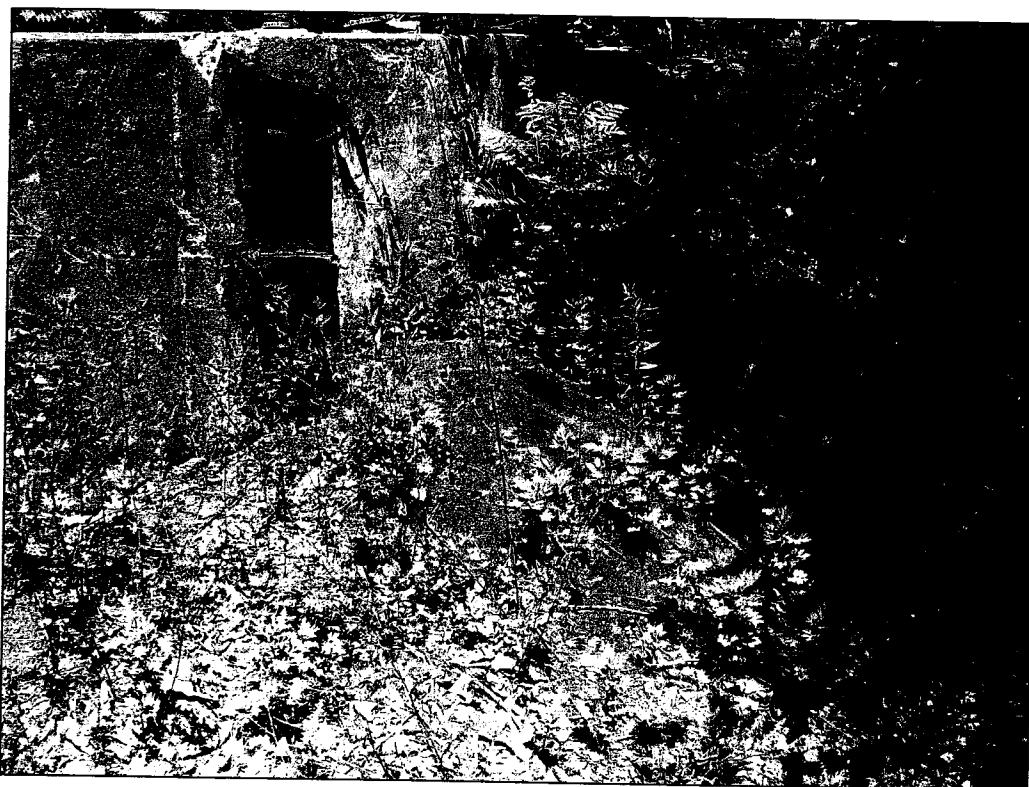
**LOCATION 5-PHOTO 2:** SLAG MATERIAL ON SURFACE AT EDGE OF FORMER REICHOLD AND USMR PROPERTY AND FENCE LINE NEAR CONCRETE BLOCKS (06/25/2008).

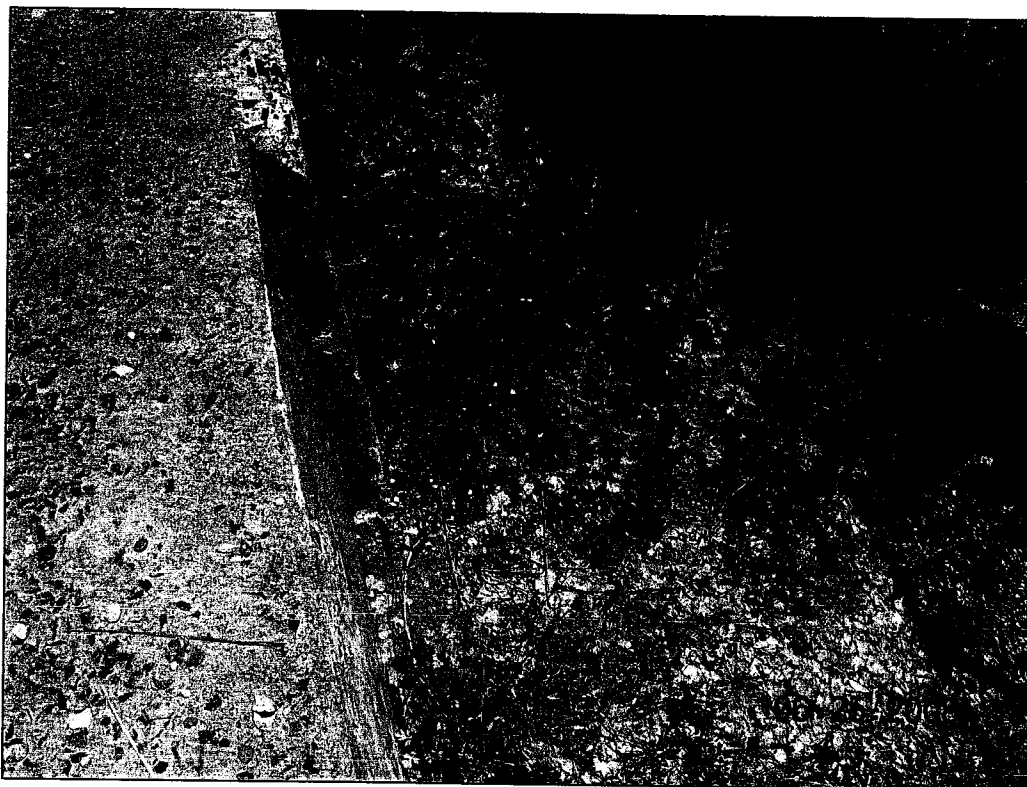
**LOCATION 5-PHOTO 3:** SLAG MATERIAL ON SURFACE SOILS AT EDGE OF FORMER REICHHOLD AND USMR PROPERTY AND FENCE LINE NEAR CONCRETE BLOCKS (06/25/2008).

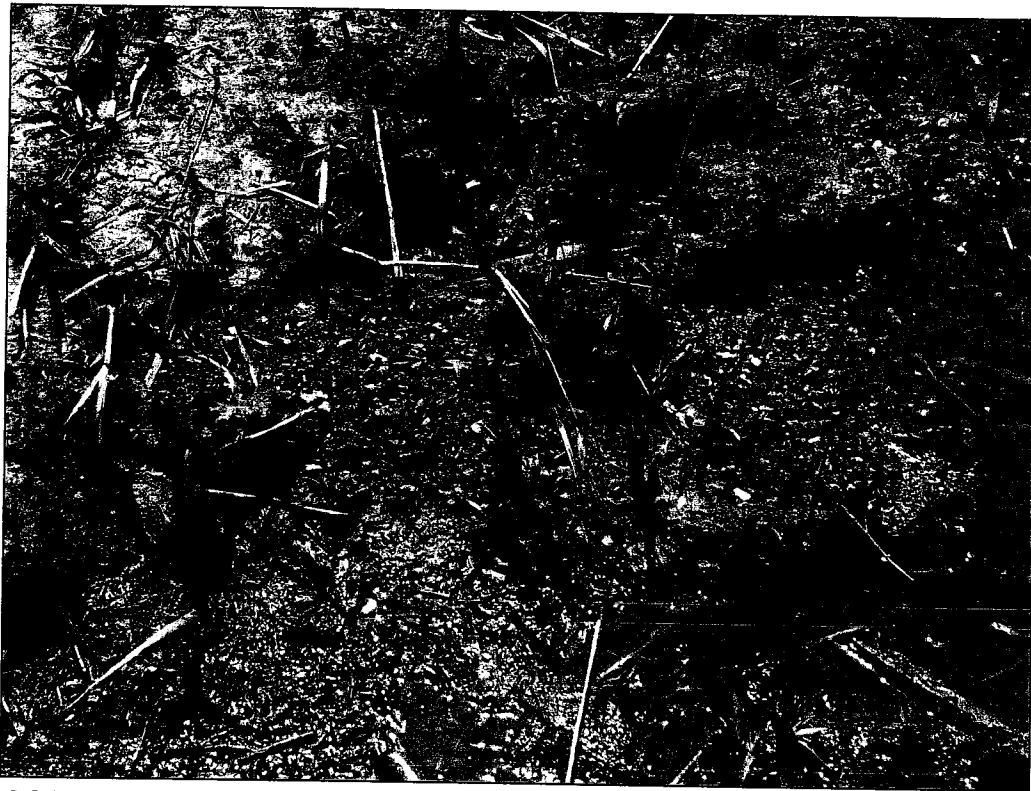
**LOCATION 7-PHOTO 3:** SLAG IN SEDIMENTS AT THE EDGE OF CARTERET DITCH NEAR THE CONFLUENCE WITH ARTHUR KILL LOCATED DOWN SLOPE OF USMR SLAG DISPOSAL AREAS ON THE FORMER REICHHOLD PROPERTY (04/23/2008).

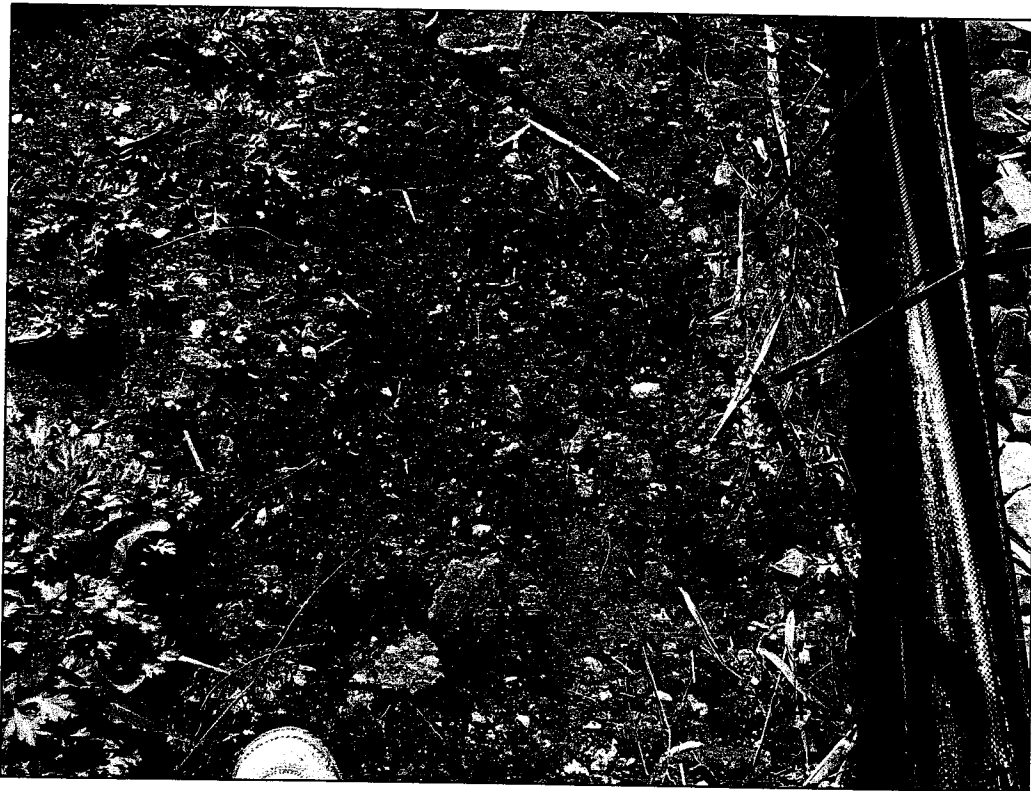
**LOCATION 8-PHOTO 3:** EAST SIDE OF CARTERET DITCH SOUTH OF MIDDLESEX AVENUE BRIDGE, EAST OF THE REMEDIATION CAP SILT FENCE. LOCATION IS DOWN SLOPE OF THE FORMER USMR LEAD PLANT AND SLAG DISPOSAL AREAS ON THE FORMER REICHHOLD PROPERTY. SOILS COVERED WITH SLAG. SAMPLE COLLECTED (04/23/2008).

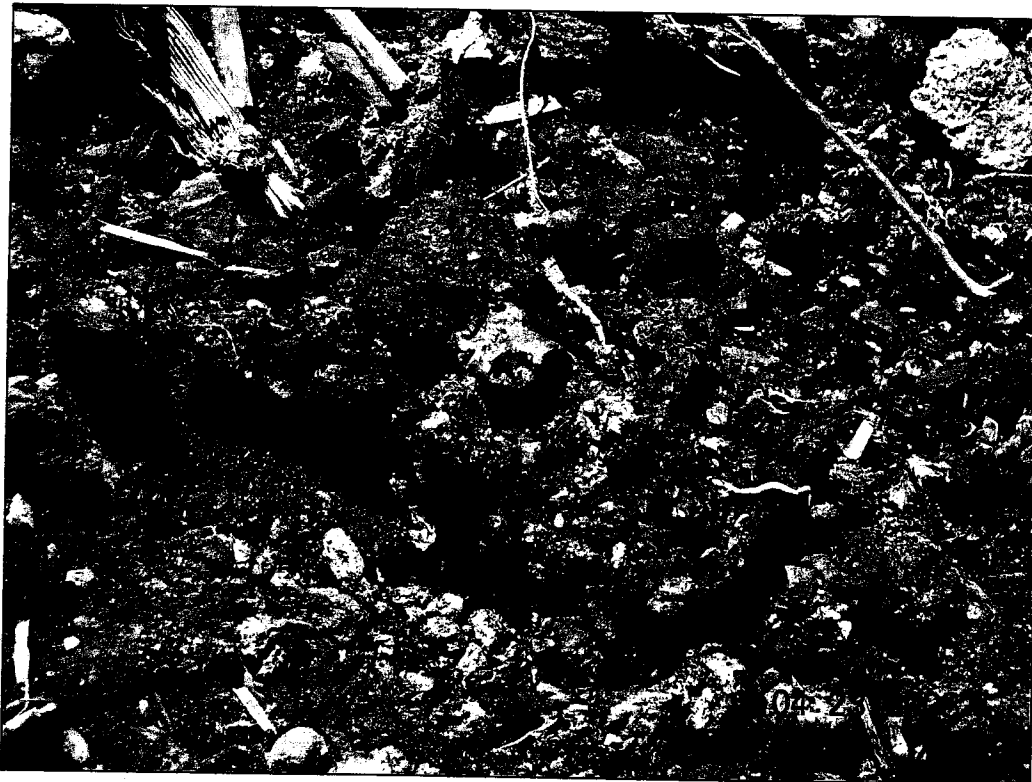
**LOCATION 8-PHOTO 4:** EAST SIDE OF CARTERET DITCH SOUTH OF MIDDLESEX AVENUE BRIDGE, EAST OF THE REMEDIATION CAP SILT FENCE. CLOSE-UP OF SLAG COVERED SOILS AT LOCATION DOWN SLOPE OF THE FORMER USMR LEAD PLANT AND SLAG DISPOSAL AREAS OF FORMER REICHHOLD PROPERTY (04/23/2008).

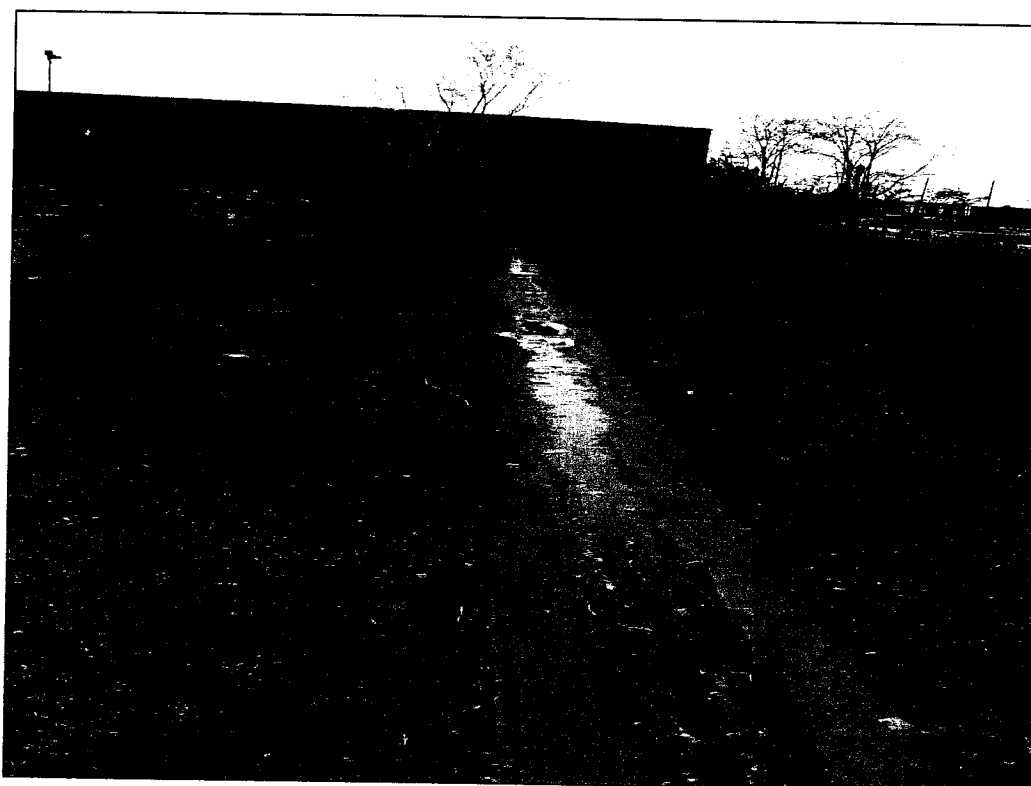
**LOCATION 10-PHOTO 8:** DRAINAGE SWALE THROUGH CARTERET WATERFRONT PARK LOCATED BETWEEN PARKING LOT AND PLAYGROUND FLOWING TO THE ARTHUR KILL. NOTE RED METALS STAINING OF WATER AND SWALE (04/23/2008).

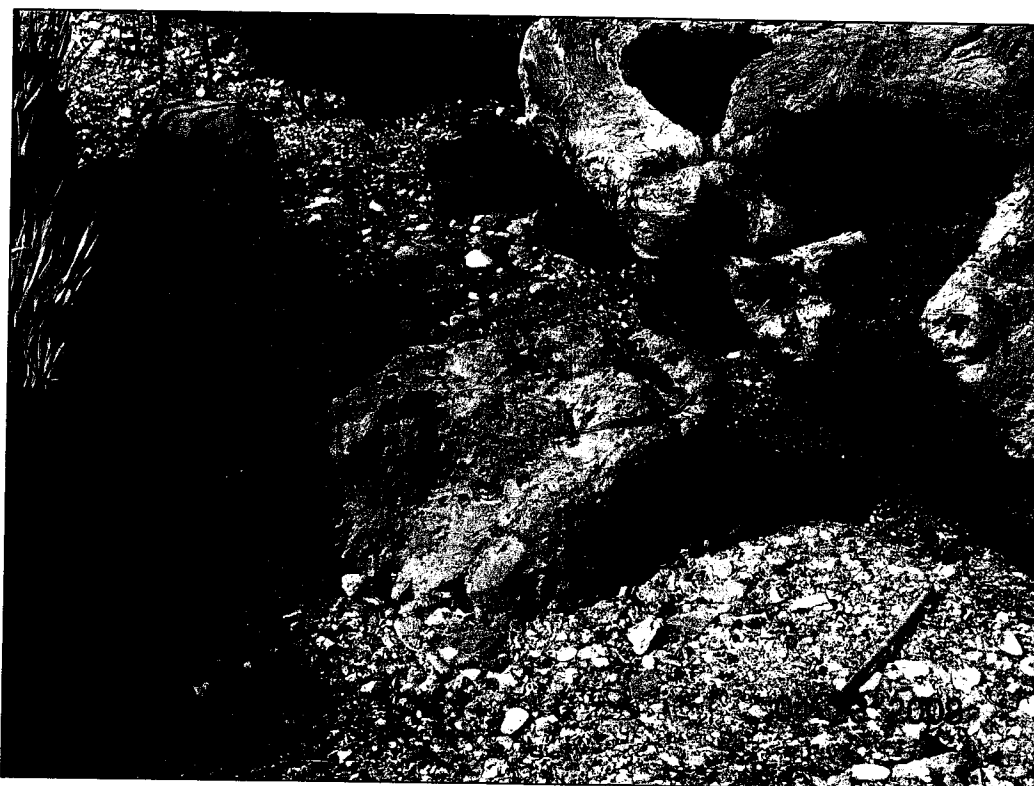
**LOCATION 11-PHOTO 2:** VETERANS MEMORIAL PIER & CARTERET WATERFRONT PARK LOCATED LESS THAN 1,000 FEET NORTHEAST OF FORMER USMR FACILITY. NOTE LARGE PIECE OF SLAG ON SHORELINE OF ARTHUR KILL TIDAL FLAT (04/23/2008).

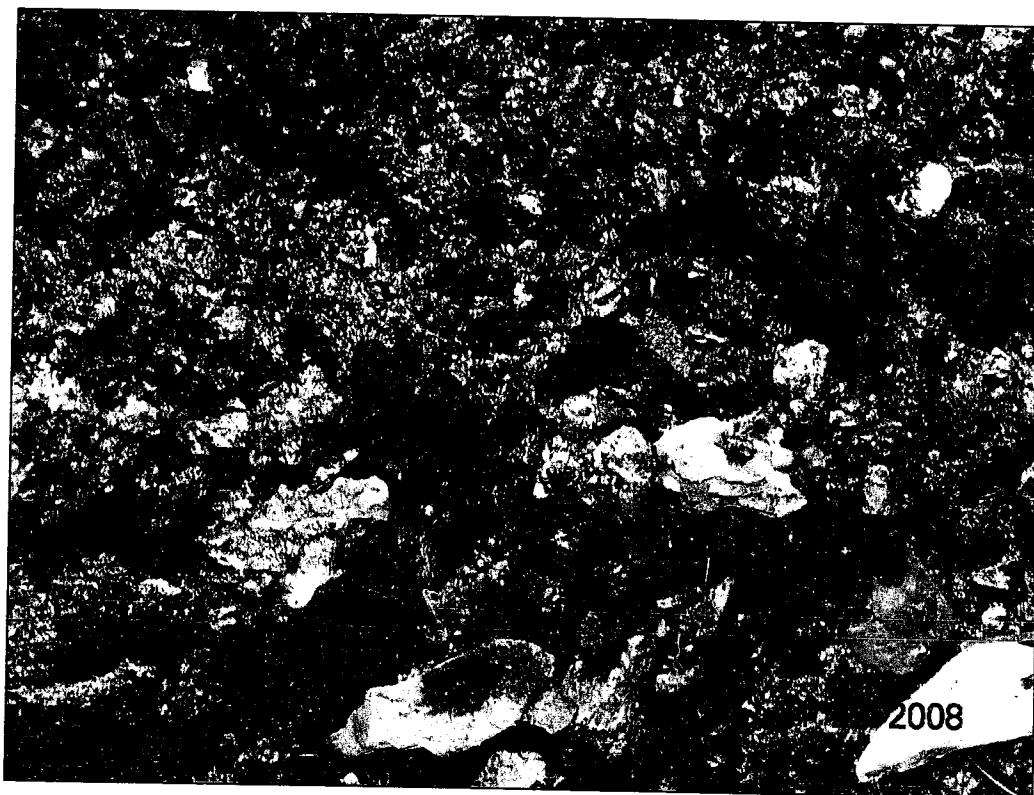
**LOCATION 13-PHOTO 5:** ARTHUR KILL SHORELINE BEACH SEDIMENTS IMMEDIATELY ADJACENT TO FORMER USMR FACILITY PROPERTY. NOTE SLAG MATERIALS COVERING SHORELINE SEDIMENTS; SAMPLE COLLECTED 04/23/2008.

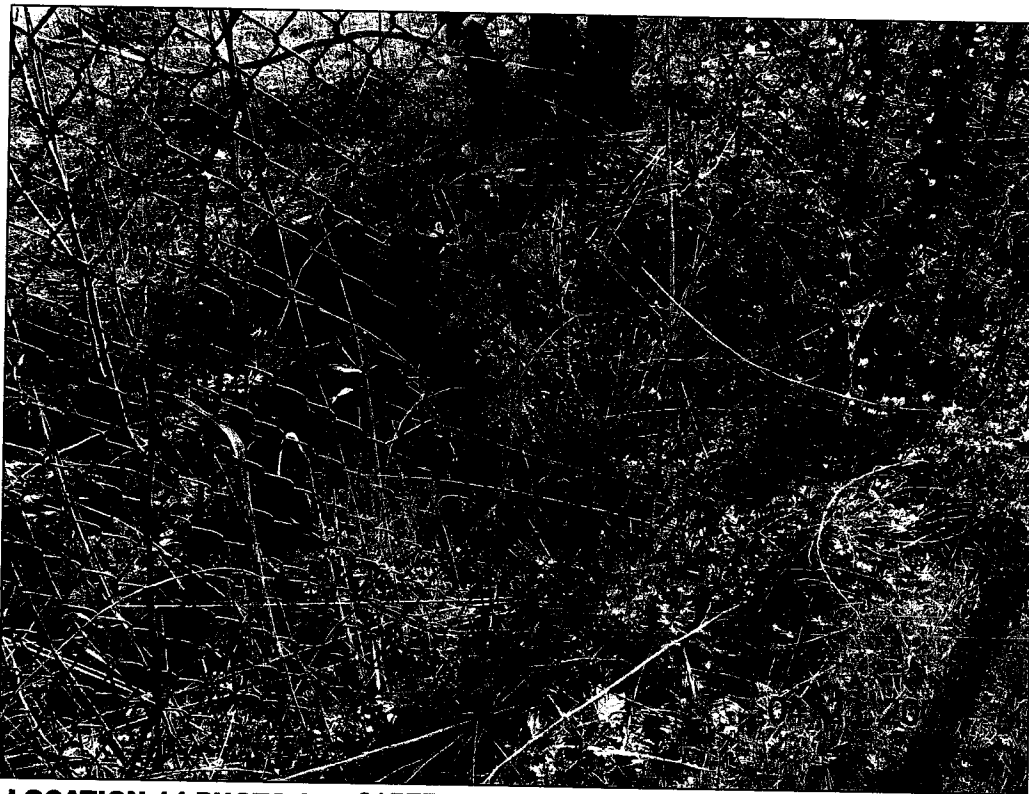
**LOCATION 14-PHOTO 3:** CARTERET WATERFRONT PARK DANIELLE'S GARDEN  
HANDICAPPED ACCESS PEDESTRIAN WALKWAY  
LOOKING THROUGH CHAINLINK FENCE AT LARGE PIECE  
OF SLAG ON FORMER USMR FACILITY PROPERTY (04/23/2008).

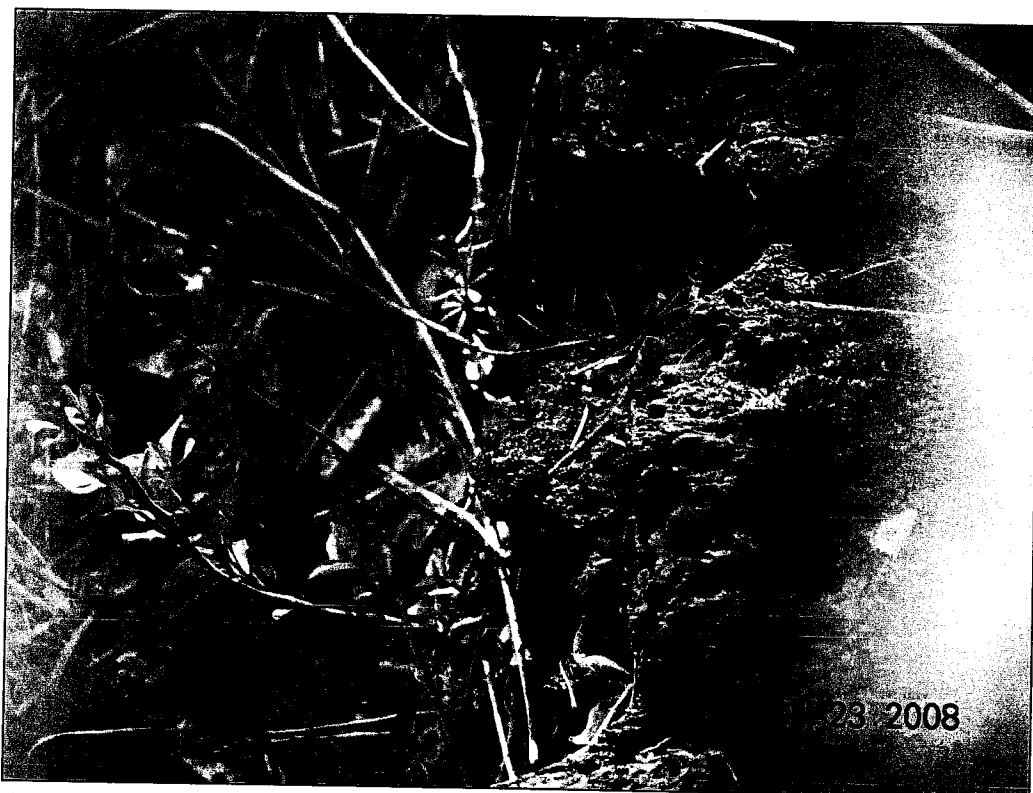
**LOCATION 14-PHOTO 5:** CLOSE-UP OF LARGE PIECE OF SLAG LOCATED ON FORMER USMR FACILITY PROPERTY NEXT TO CHAINLINK FENCE AT CARTERET WATERFRONT PARK DANIELLE'S GARDEN HANDICAPPED ACCESS WALKWAY (04/23/2008).
